MA FACE Occupational Fatality Report

Temporary Worker Died While Cleaning a Double Auger Screw Conveyor Machine – Massachusetts

Release Date: January 30, 2014 Investigation: #11-MA-050-01 Massachusetts Department of Public Health Occupational Health Surveillance Program

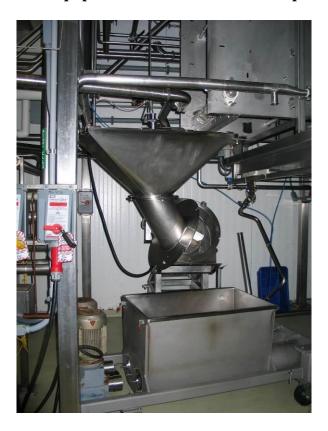
Figure 1 – The feed pump skid and grinder that was being cleaned (both pieces of equipment are disassembled in the photograph)

The incident occurred inside the company's hummus cook room where the chick peas are processed. The cook room, including all of the equipment, was designed and built approximately four years before the incident. The hummus manufacturing process begins with bags of dry chick peas that are pumped into a tank and are soaked for up to 24 hours. Then the chick peas are moved by conveyor to a destoner, which removes stones or other objects from the chick peas, and then pumped to a cook kettle. The chick peas are cooked at 250 degrees Fahrenheit for 20 minutes. The chick peas are then pumped into a grinder and the ground chick peas then enter a feed pump skid. The feed pump skid is the machine that the victim was cleaning at the time of the incident (Figure #1). The feed pump skid pumps the ground chick peas into a pipe and out of the cook room to the next part of the hummus manufacturing process.

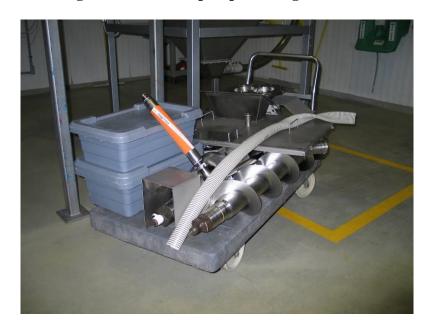
The grinder is located above the feed pump skid and both pieces of equipment are made of stainless steel. The feed pump skid has two nine-inch diameter augers (Figure #2) that rotate in opposite directions. The augers are powered by an electric motor. The rotation of these augers is what moves or pushes the ground chick peas into the pipe. The double augers are housed inside and at the bottom of the feed pump skid's rectangular tub (Figure #3). The tub has a removable lid. The entire feed pump skid, including the electric motor, is fastened to a frame with wheels.

Figure 2 – The feed pump skid augers and lid

interaction and the need to incorporate engineering controls to prevent or control this potential interaction. For example, incorporating an interlock into the design of the power control circuit for the augers that would shut down or prevent start-up of the auger motors if the tub lid is removed could eliminate or minimizing the risk of injury from being caught by the augers.

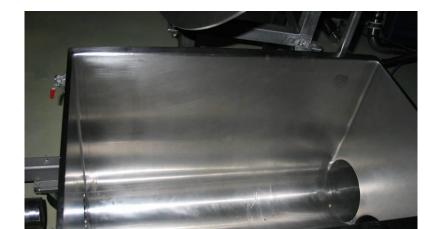
Figure 3 – The feed pump skid tub with augers removed

After the incident, a hand scraper was found inside the machine's tub between the two augers, but it could not be determined that the victim was using the scraper at the time of the incident. It was reported in the police report that there were several inches of water mixed with ground chick pea on the floor of the cook room that made the floor of the room slippery. The cook room did have three floor drains, but at the time of the incident they were clogged with ground chick peas and were not allowing the water to drain. It has been suggested that because the floor was slippery, the victim lost his balance and fell into the machine with the rotating augers.

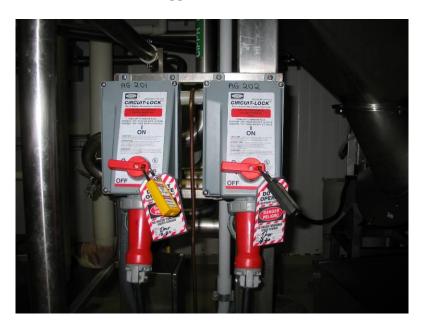
The feed pump skid and grinder were wired with an emergency stop and the ability to be locked out (Figure #4). The victim was cleaning the feed pump skid at the time of the incident and was wearing rubber boots, an apron, sleeves and gloves. There were two other co-workers in the cook room at this same time; one was also a cleaner and the other co-worker was a cook room operator preparing for the next shift.

Figure 4 – The feed pump skid circuit shut off that is locked and tagged out after the incident

In this case, it should be ensured that the lockout/tagout procedure for the feed pump skid, and all other machines in the facility, are comprehensive. These procedures should include specific requirements on how to properly perform lockout/tagout on each machine, as well as when lockout/tagout should be implemented. Involving employees in the process of reviewing and updating the hazardous energy control program is important. The employer should seek input from employees by having employees evaluate the effectiveness and limitations of the hazardous energy control program. Employers should ask employees about techniques involved in completing tasks that require them to expose any part of their bodies to machine and equipment hazards, especially cleaning and maintenance activities and common procedures that are not typically thought of as part of the everyday operation. Employees who spend the majority of their time operating and performing maintenance tasks on machines and equipment will be able to contribute valuable information that might have been overlooked, and these employees will likely be able to contribute the most information about the effectiveness and limitations of the hazardous energy control program.
